# Property Inspection Report

John Buyer  
123 Main St.  
Anytown, IL. 60123

# Housedoctors Property Inspections

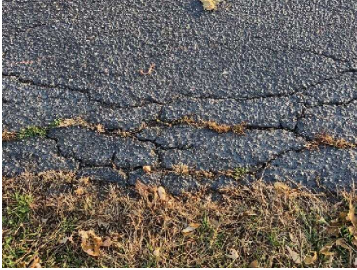
1.  Driveway: Asphalt - Surface cracking in spots.

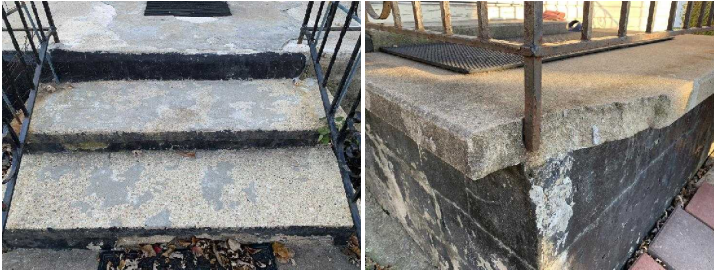
4.  Porch: Concrete - Front porch surface spalling in spots. Exposed aggregate in spots. Back porch corner broken off. Handrail/guardrail loose. Safety issue. Repair as needed.

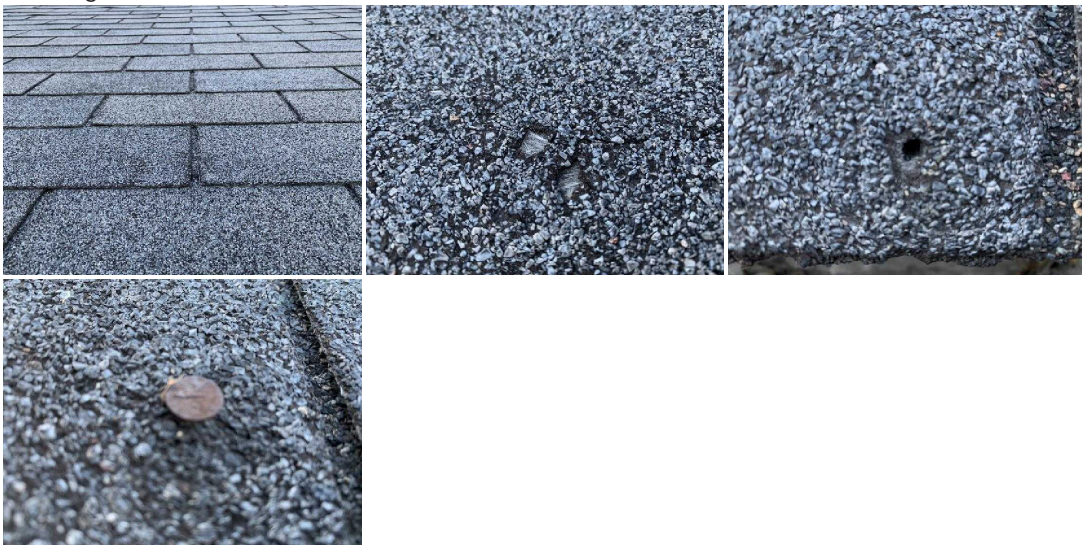
- Method of Inspection: Ladder at eaves
- Material: Shingles - Shingles showing signs of age. Brittle in spots. Loss of surface granules in spots. Fractured/broken shingles in spots. Improper surface nailed repair above front door. Roof nearing end of life.

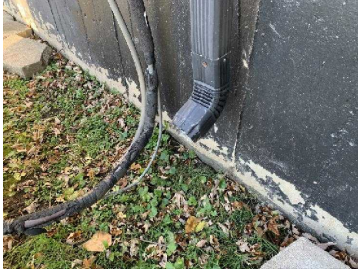
6.  Gutters: Aluminum - Recommend downspout extensions as needed.

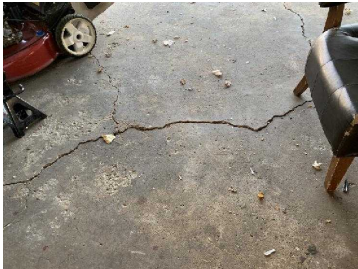
2.  Ceiling: Drywall, Exposed framing
3.  Walls: Drywall
4.  Floor/Foundation: Poured concrete - Garage slab cracked/displaced. Trip hazard.

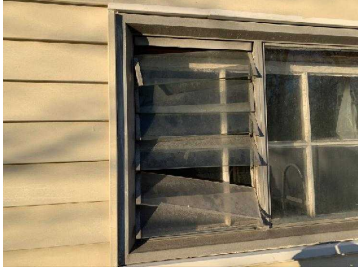
8.  Exterior: Marginal - Garage window needs repair.

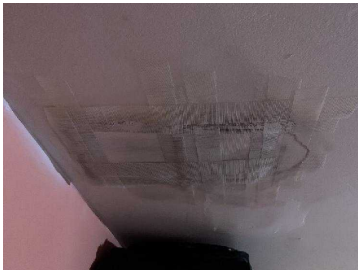
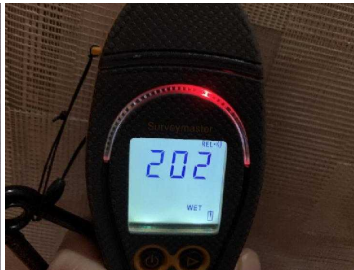
1.  Closets: Marginal - No closet in North rear bedroom.  
2.  Ceilings: Drywall - Staining/discoloration on basement bedroom ceiling with high moisture reading. Have checked.

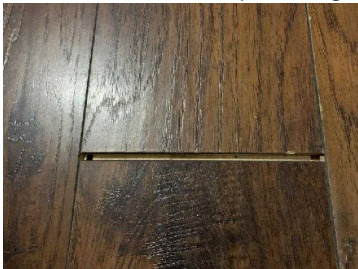
3.  Walls: Drywall  
4.  Floors: Laminate, Ceramic, Vinyl - 1st floor rear bath floor soft in spots. Possible sub floor rot. Laminate floors separating in spots.

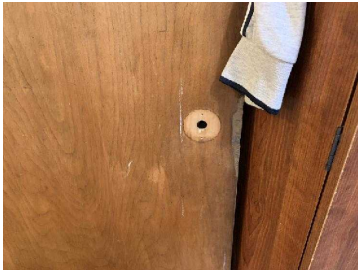
5.  Doors: Hollow wood - Rear South bedroom entry door missing handle.

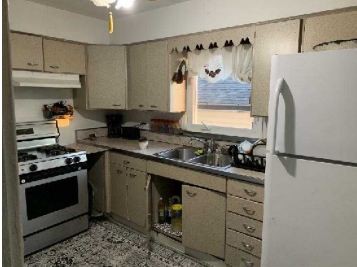
6.  Kitchen Cabinets: Composite and wood - Some cabinet doors don't latch. Repair as needed.

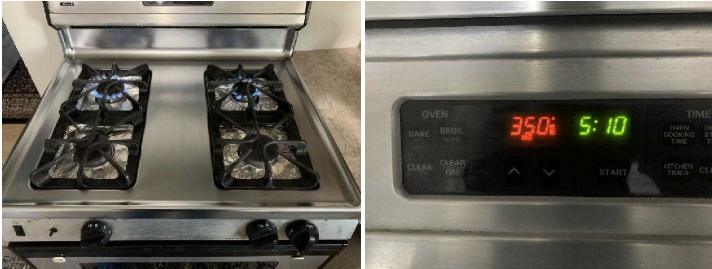
1.  Cooking Appliances: Kenmore - Stove front burners would not light. Left front burner missing knob. Oven door missing handle. Repair as needed.

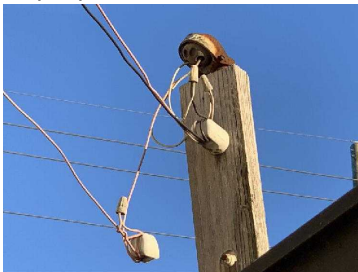
1.      Service Entrance: Above Ground From Mast - Splices on service wires to garage with wire nuts are improper. Recommend further review by Electrician and repairs as needed.

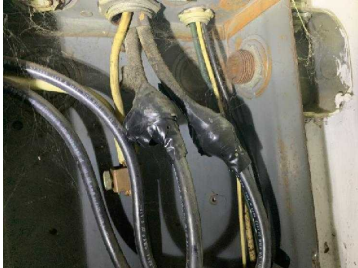
3.      Service: Copper - Service wires spliced in panel box. Should be continuous from the service drop to the panel. Recommend further review by Electrician and repairs as needed.

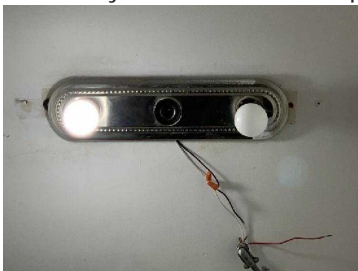
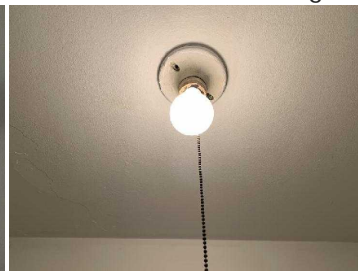
5.      Interior Lighting: Marginal - Interior lighting wired improperly throughout the house. Kitchen 3 way switch not operating properly. Resistance buzz at 1st floor front bedroom light. Recommend further review by Electrician and repairs as needed. Closet lights should not be open bulbs.

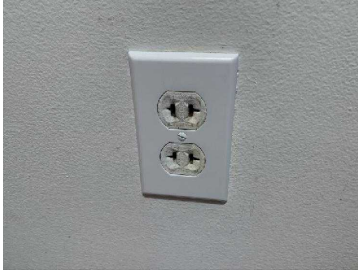
6.  120 VAC Outlets: Marginal - Loose outlets in 1st floor front bathroom and kitchen back wall. Repair as needed. No outlet in rear bathroom. Recommend updating 2 prong outlets to 3 prong with ground as needed.

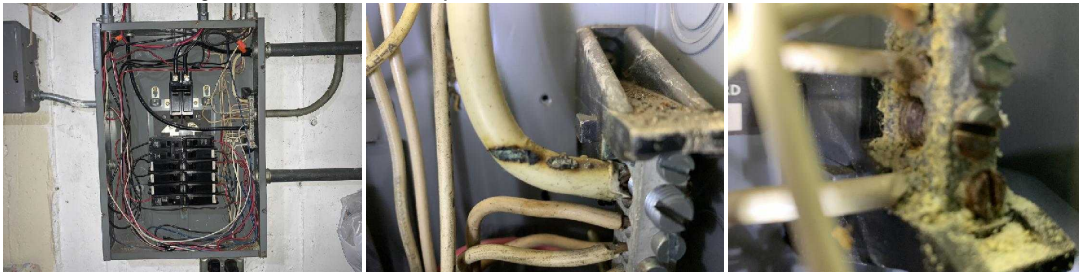
7.  Manufacturer: Sylvania - Neutral wire scorched at bus bar. Heavy corrosion on bus bar. Recommend further review by Electrician and repairs as needed.

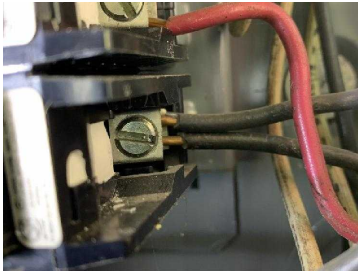
10.  Breakers: Marginal - Multiple double tap breakers in panel. No open positions. Recommend further review by Electrician and repairs as needed.

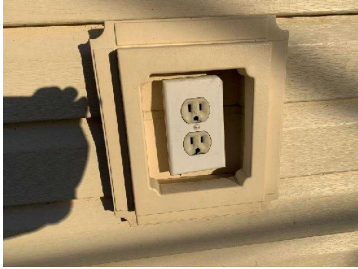
14.  Exterior Electric Outlets: Marginal - Exterior front outlet not working. Exterior outlets should be GFCI with weather tight covers.

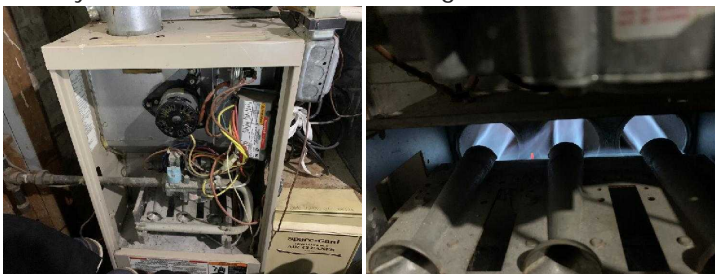
- Heating System Operation: Marginal - Furnace may be nearing end of life. Average life expectancy is 20 years. Furnace needs cleaning.

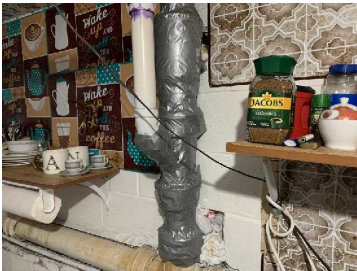
3.      Drain Pipes: Marginal - Main waste pipe wrapped with duct tape in the basement. Reason unknown. Have checked.

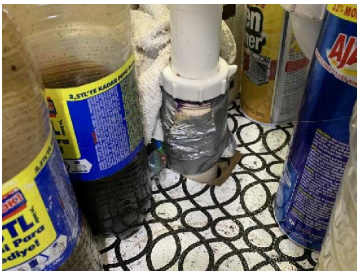
6.      Faucets/Traps: Marginal - Kitchen sink faucet hot/cold reversed. Kitchen sink drain should be "P" trap. Previous repairs to kitchen sink drain. Tub spigot loose and not flush with the wall in front bath. Tub drains slow in front bath. Have checked.

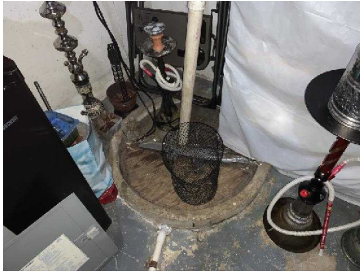
7.  Sump Pump: Submerged - Recommend battery back up for sump. Could not determine sump discharge location.

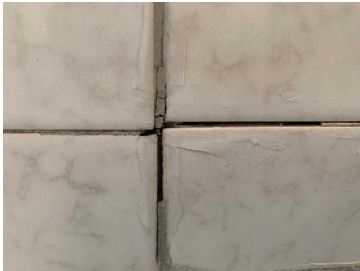
8.  Tub/Surround: Steel tub and ceramic surround - Cracked tiles in spots in front bath tub area. Missing grout in spots. Repair as needed.

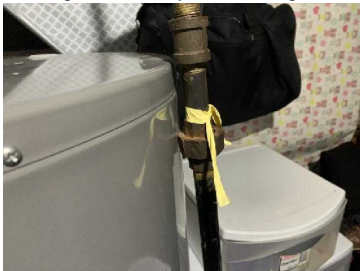
10.  Water Heater Operation: Marginal - Gas leak at water heater gas line unions next to heater. Marked with yellow tape. Safety issue. Have corrected ASAP.

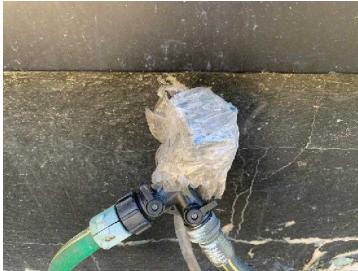
16.  Hose Bibs: Side, Rear - Hose bib on rear wall covered with plastic. Reason unknown. Did not test. Recommend replacing existing hose bibs with frost free type.

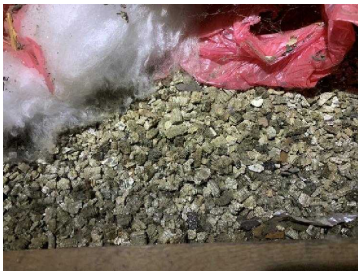
3.  Sheathing: Plywood  
4.  Insulation: Marginal - Loose insulation in the attic appears to be vermiculite which likely contains asbestos. Recommend safe removal by qualified contractor.

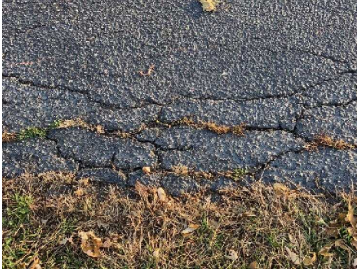
1. Driveway: Asphalt - Surface cracking in spots.

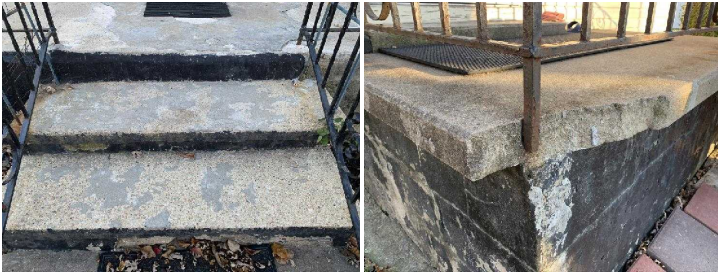
2. Porch: Concrete - Front porch surface spalling in spots. Exposed aggregate in spots. Back porch corner broken off. Handrail/guardrail loose. Safety issue. Repair as needed.

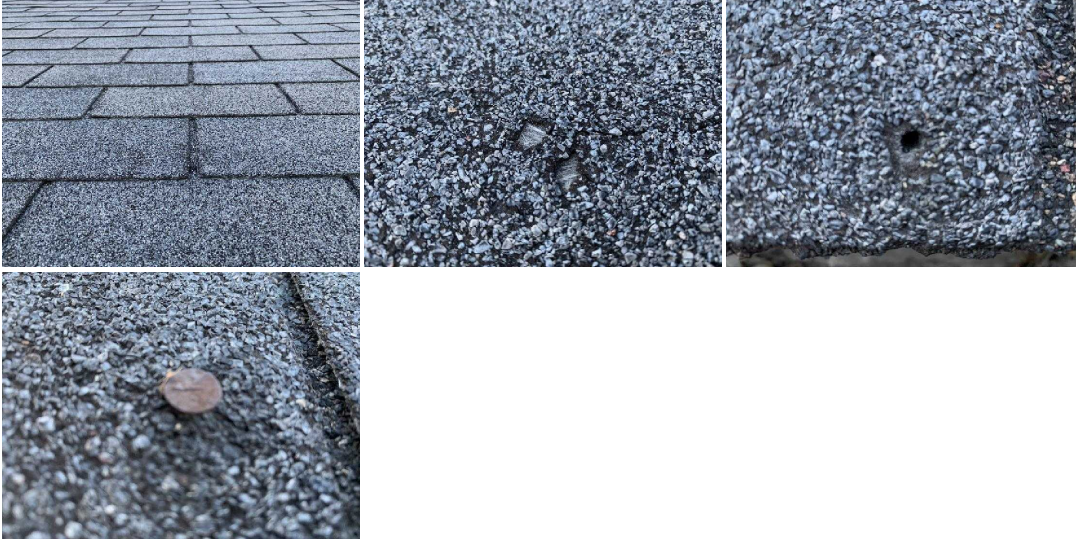
5. Main Roof Surface Material: Shingles - Shingles showing signs of age. Brittle in spots. Loss of surface granules in spots. Fractured/broken shingles in spots. Improper surface nailed repair above front door. Roof nearing end of life.

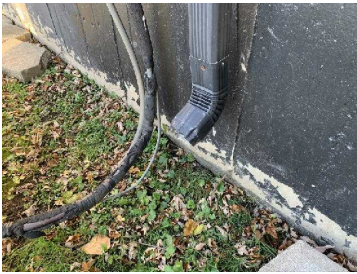
6. Gutters: Aluminum - Recommend downspout extensions as needed.

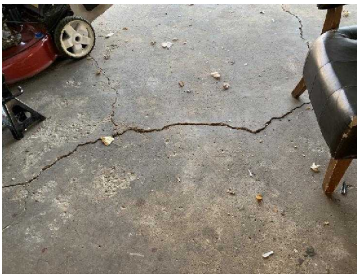
7. Floor/Foundation: Poured concrete - Garage slab cracked/displaced. Trip hazard.

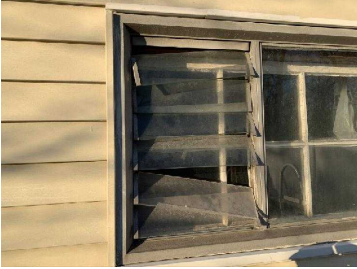
10. Exterior: Marginal - Garage window needs repair.

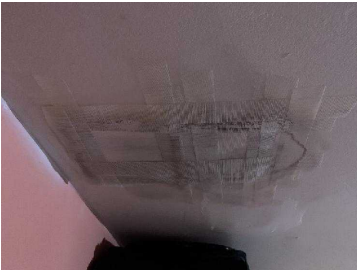
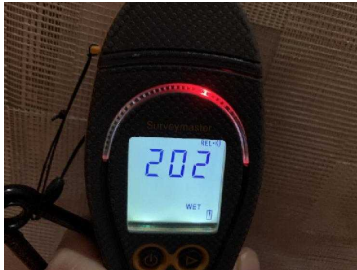
11. Closets: Marginal - No closet in North rear bedroom.
12. Ceilings: Drywall - Staining/discoloration on basement bedroom ceiling with high moisture reading. Have checked.

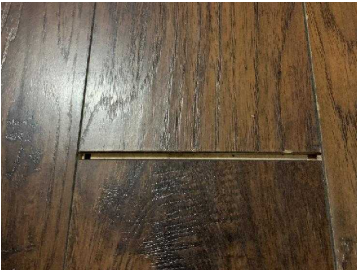
13. Floors: Laminate, Ceramic, Vinyl - 1st floor rear bath floor soft in spots. Possible sub floor rot. Laminate floors separating in spots.

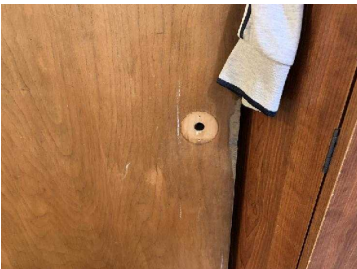
14. Doors: Hollow wood - Rear South bedroom entry door missing handle.

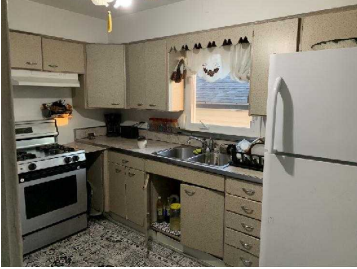
15. Kitchen Cabinets: Composite and wood - Some cabinet doors don't latch. Repair as needed.

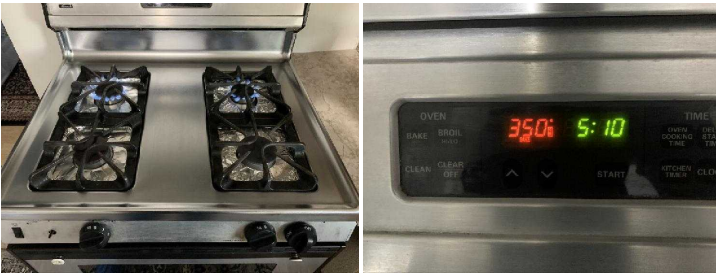
17. Cooking Appliances: Kenmore - Stove front burners would not light. Left front burner missing knob. Oven door missing handle. Repair as needed.

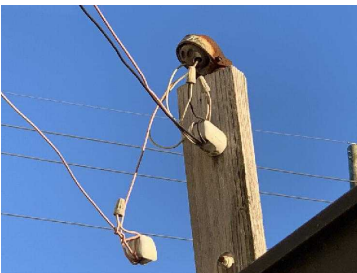
18. Service Entrance: Above Ground From Mast - Splices on service wires to garage with wire nuts are improper. Recommend further review by Electrician and repairs as needed.

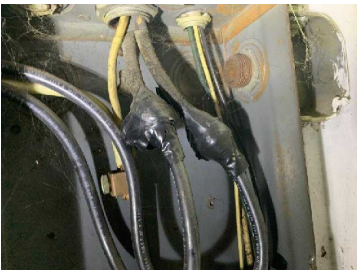
19. Service: Copper - Service wires spliced in panel box. Should be continuous from the service drop to the panel. Recommend further review by Electrician and repairs as needed.

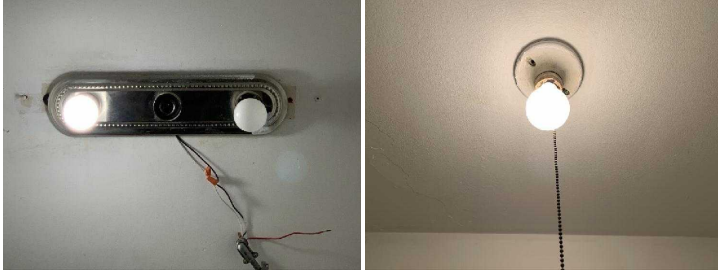
20. Interior Lighting: Marginal - Interior lighting wired improperly throughout the house. Kitchen 3 way switch not operating properly. Resistance buzz at 1st floor front bedroom light. Recommend further review by Electrician and repairs as needed. Closet lights should not be open bulbs.

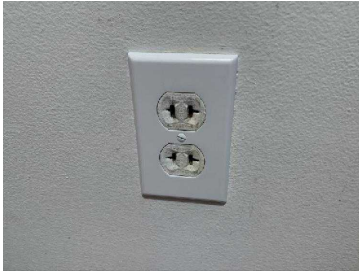
21. 120 VAC Outlets: Marginal - Loose outlets in 1st floor front bathroom and kitchen back wall. Repair as needed. No outlet in rear bathroom. Recommend updating 2 prong outlets to 3 prong with ground as needed.

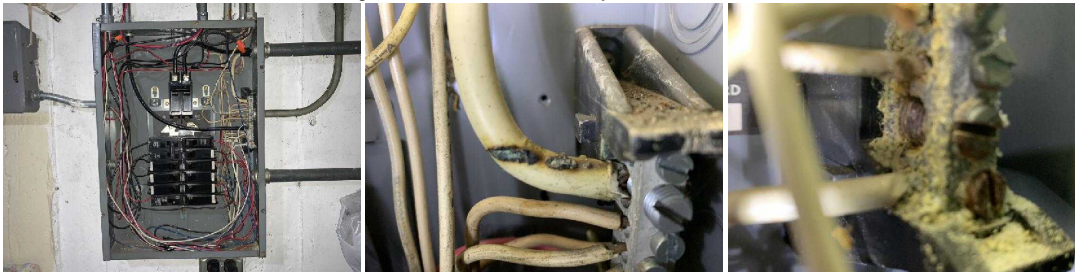
22. Basement Electric Panel Manufacturer: Sylvania - Neutral wire scorched at bus bar. Heavy corrosion on bus bar. Recommend further review by Electrician and repairs as needed.

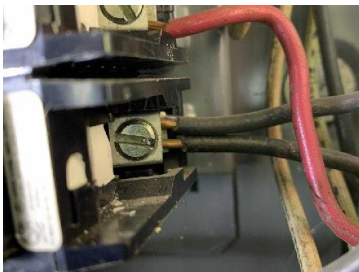
23. Basement Electric Panel Breakers: Marginal - Multiple double tap breakers in panel. No open positions. Recommend further review by Electrician and repairs as needed.

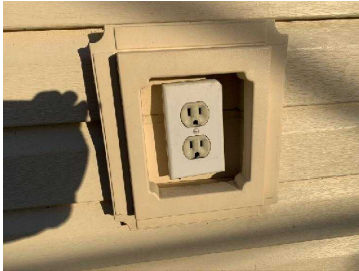
26. Exterior Electric Outlets: Marginal - Exterior front outlet not working. Exterior outlets should be GFCI with weather tight covers.

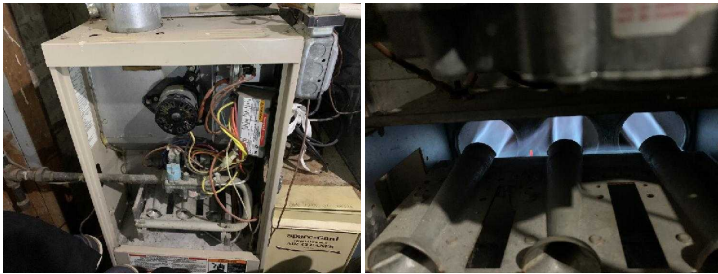
28. Main Heating System Heating System Operation: Marginal - Furnace may be nearing end of life. Average life expectancy is 20 years. Furnace needs cleaning.

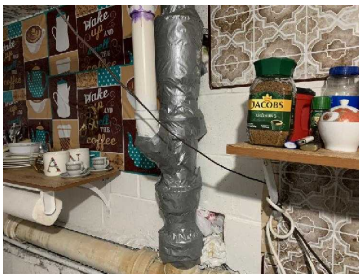
29. Drain Pipes: Marginal - Main waste pipe wrapped with duct tape in the basement. Reason unknown. Have checked.

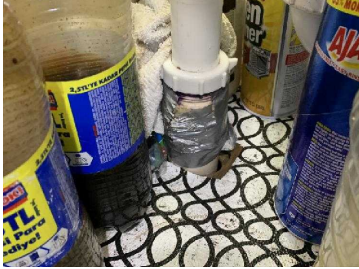
30. Faucets/Traps: Marginal - Kitchen sink faucet hot/cold reversed. Kitchen sink drain should be "P" trap. Previous repairs to kitchen sink drain. Tub spigot loose and not flush with the wall in front bath. Tub drains slow in front bath. Have checked.

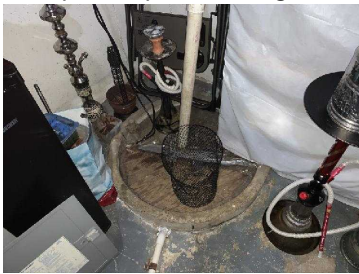
31. Sump Pump: Submerged - Recommend battery back up for sump. Could not determine sump discharge location.

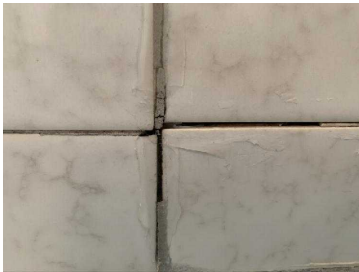
32. Tub/Surround: Steel tub and ceramic surround - Cracked tiles in spots in front bath tub area. Missing grout in spots. Repair as needed.

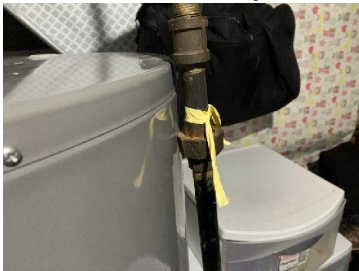
34. Basement Water Heater Water Heater Operation: Marginal - Gas leak at water heater gas line unions next to heater. Marked with yellow tape. Safety issue. Have corrected ASAP.

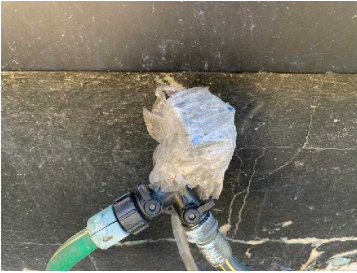
37. Hose Bibs: Side, Rear - Hose bib on rear wall covered with plastic. Reason unknown. Did not test. Recommend replacing existing hose bibs with frost free type.

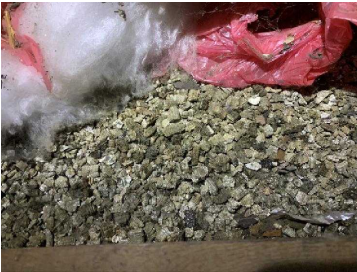
38. Main Attic Insulation: Marginal - Loose insulation in the attic appears to be vermiculite which likely contains asbestos. Recommend safe removal by qualified contractor.
