# Property Inspection Report

John Buyer  
123 Main St.  
Anytown, IL. 60123

# Housedoctors Property Inspections

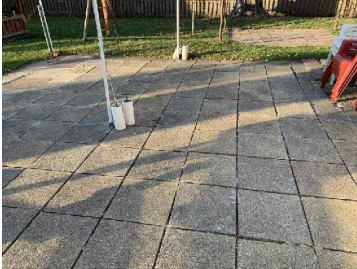
4.  Porch: Concrete - Front porch surface spalling in spots. Exposed aggregate in spots. Back porch corner broken off. Handrail/guardrail loose. Safety issue. Repair as needed.

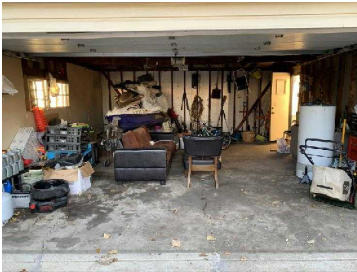
2.  Ceiling: Drywall, Exposed framing
3.  Walls: Drywall
4.  Floor/Foundation: Poured concrete - Garage slab cracked/displaced. Trip hazard.

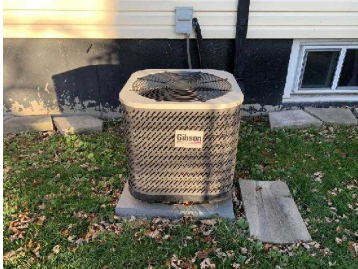
- A/C System Operation: Not inspected - To avoid possible compressor damage due to outside temperature below 65 degrees, the unit was not tested. A/C may be nearing end of life. Average life expectancy is 12 years. R-22 refrigerant is no longer available for this unit.
- Exterior Unit: Pad mounted

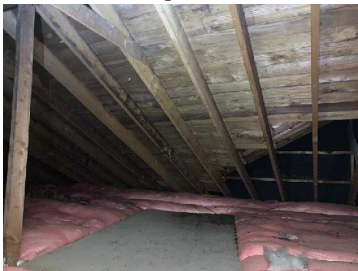
3.  Sheathing: Plywood  
4.  Insulation: Marginal - Loose insulation in the attic appears to be vermiculite which likely contains asbestos. Recommend safe removal by qualified contractor.
